Hawthorne Meadow Feasibility Study

The Town of Amherst office of Conservation and Development

By: Coldham & Hartman Architects 49 South Pleasant Street Amherst MA 01002

June 19th 2012

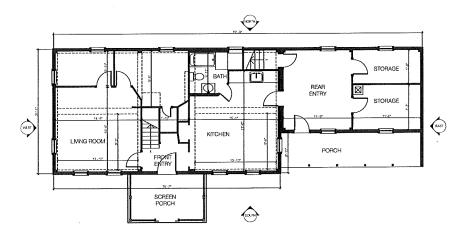
First floor plan as existing

The Hawthorne House has a four-room plan with a straight-run, center stair. A center chimney was removed from the house from basement to the roofline in order to provide the center staircase. The loss of the center chimney and insertion of a straight run stairway is unfortunate for the integrity of the house, as is loss of the main entry door surround.
